**Baseline Property Condition Assessment  
Sacred Heart of Jesus Parish  
3060 John Street and 549 Middle Street  
Cardinal, Ontario**

Prepared for:  
Archdiocese of Kingston  
390 Palace Road  
Kingston, Ontario K7L 4T3

September 2013

Pinchin File: 78518.019

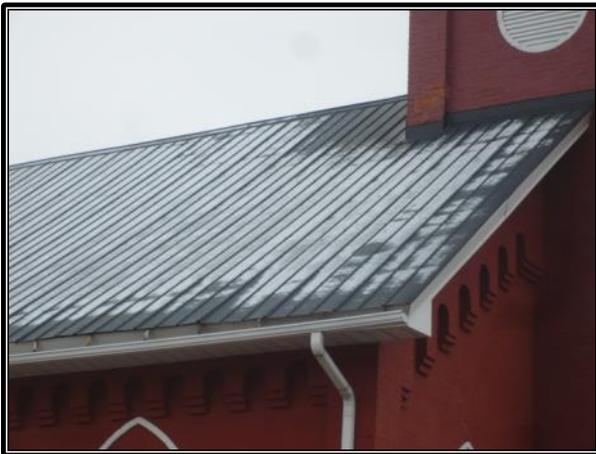
General view of a sloped metal roof system which serves the west portion of Site Building A.

Note: The finishes on the metal roof was noted to be faded/deteriorated.

Pinchin has carried an allowance to re-finish the metal roof systems located on the west portion of Site Building A. Replacement of the impact damaged downspout should also be replaced within the term of the analysis. Assuming that the above noted deficiencies are addressed and regular annual maintenance is performed, the roof systems serving the Site Buildings should continue to perform in a satisfactory manner throughout the term of the analysis.

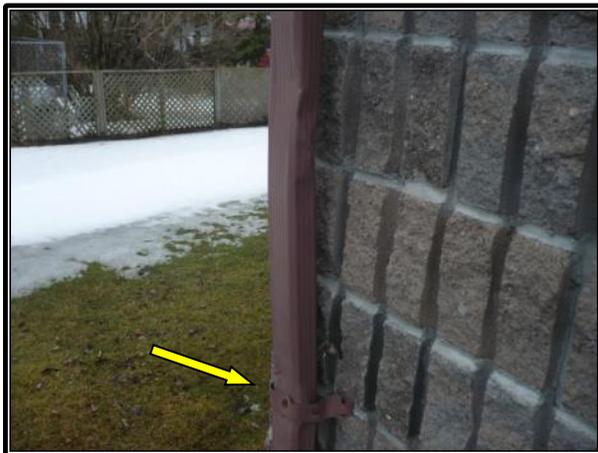
View of an impact damaged downspout located on the northeast corner of Site Building B.

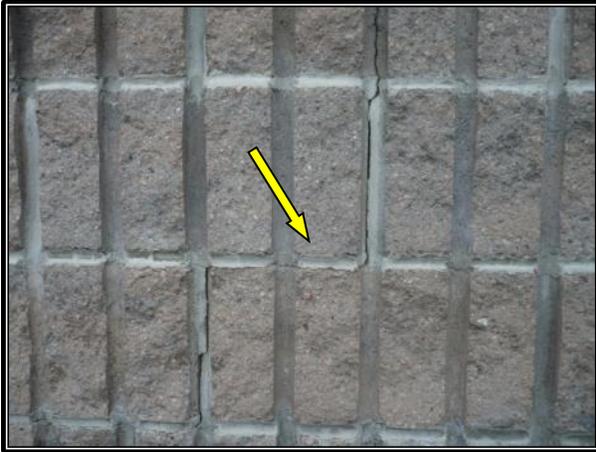
View of step cracking and cracked architectural concrete block masonry units located on the south elevation of Site Building B.

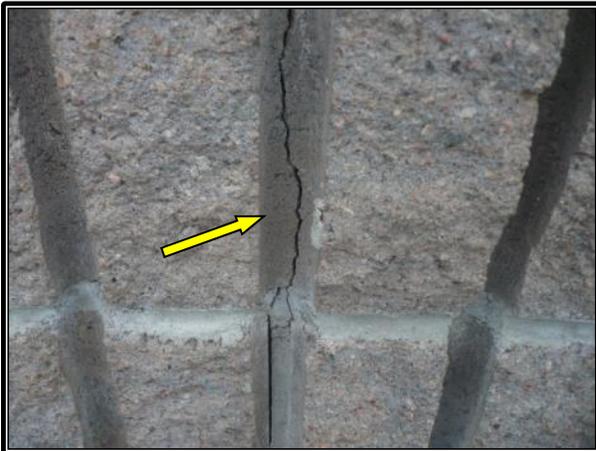
View of a cracked architectural concrete block masonry unit located on the north elevation of Site Building B.

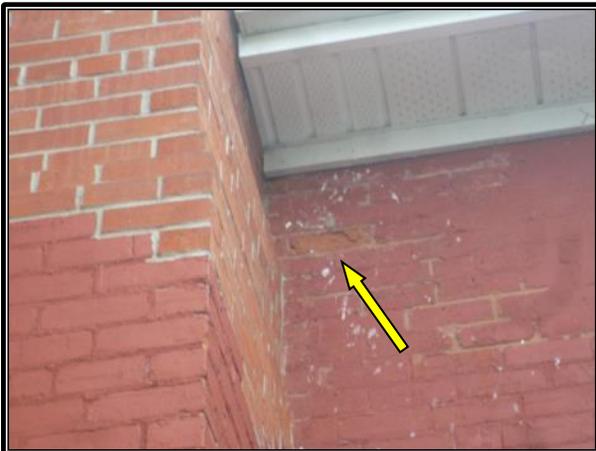
View of a spalled brick masonry unit located on the east elevation of Site Building A.

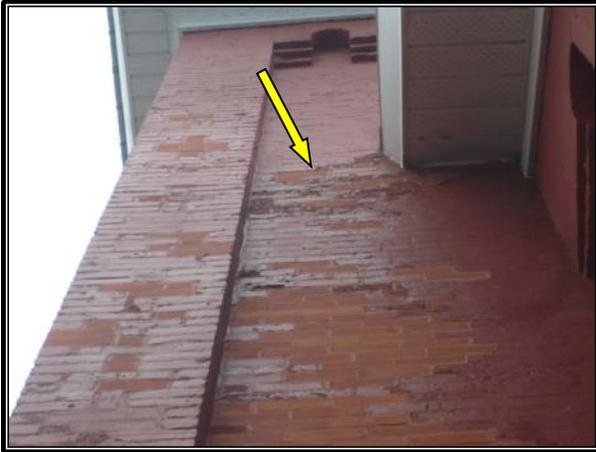
View of peeling paint and spalled brick masonry located on the south elevation of Site Building A.

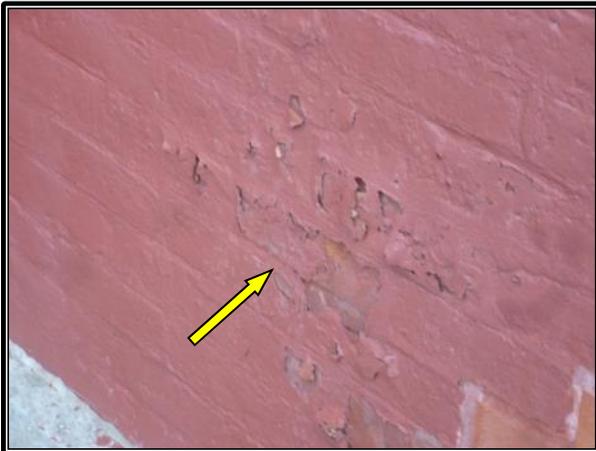
View of typical peeling paint on the brick masonry walls of Site Building A.

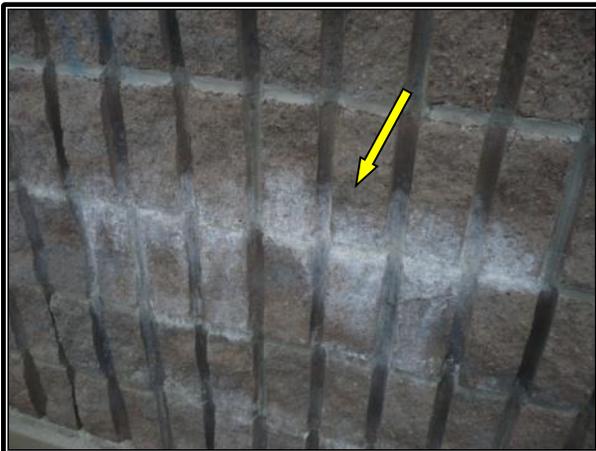
View of efflorescence on the architectural concrete block masonry units on the north elevation of Site Building B.

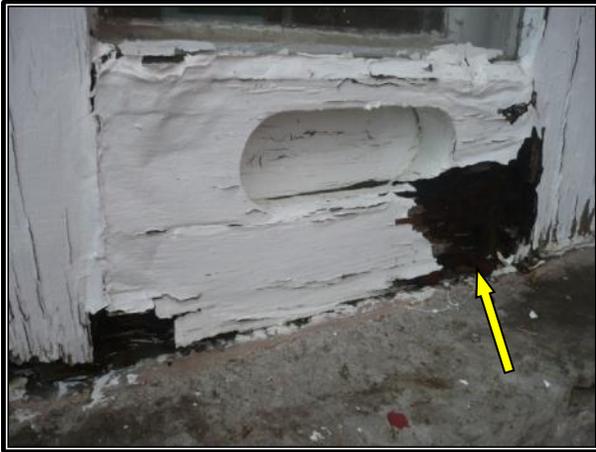
View of a rotten wood window frame located on the west elevation of Site Building A.

The wall, window and door systems of the Site Buildings were generally noted to be in satisfactory condition at the time of the Site visit with the exception of the above noted minor deficiencies. Pinchin has carried allowances to complete repairs to the brick masonry and the concrete block masonry walls throughout the term of the analysis. Allowances have also been carried to refinish the wood window frames and to replace the perimeter window sealants at both Site Buildings. Replacement of the rotten wood window frame should be completed in the short term.

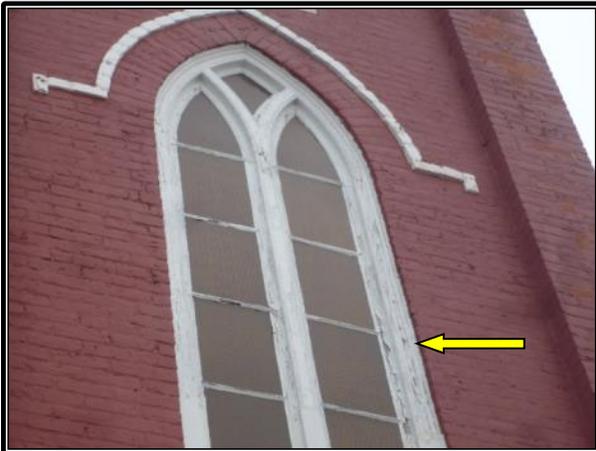
View of chipping paint on the wood window frame on a window system located on the south elevation of Site Building A.

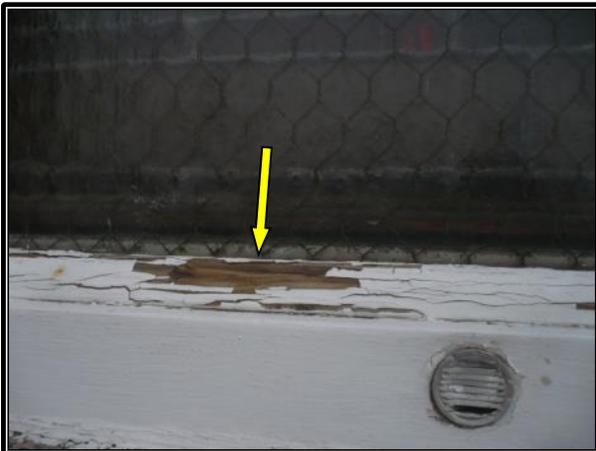
View of typical chipping paint on the wood window frames of Site Building A.

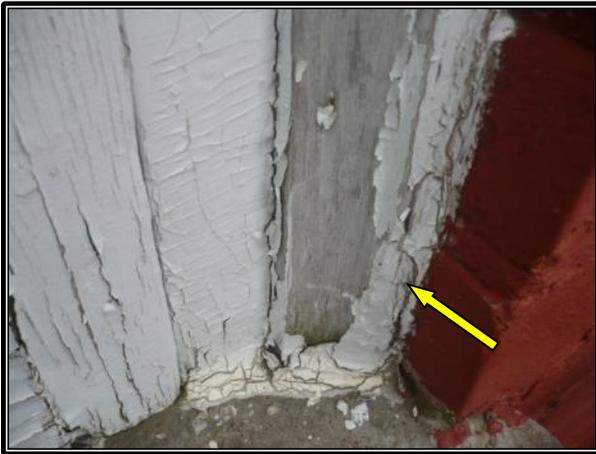
View of chipping paint and a deteriorated perimeter window sealant on a wood window frame located on the north elevation of Site Building A.

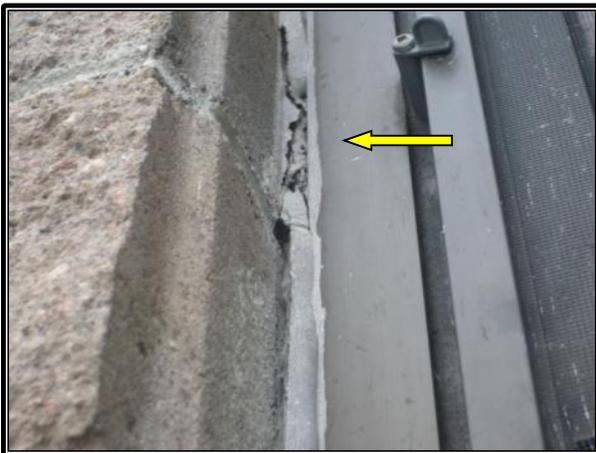
View of a cracked and deteriorated perimeter window sealant located on the south elevation of Site Building B.

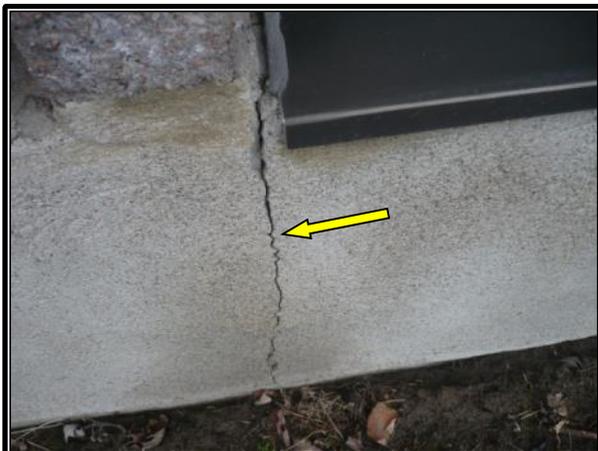
View of an area of cracking in the concrete foundation wall on the south elevation of Site Building B.

It should be noted that an area of cracking was observed in the concrete foundation wall on the south elevation of Site Building B. Pinchin recommends that the area of cracking be sealed within the short term and that the area of cracking be monitored for any further movement.

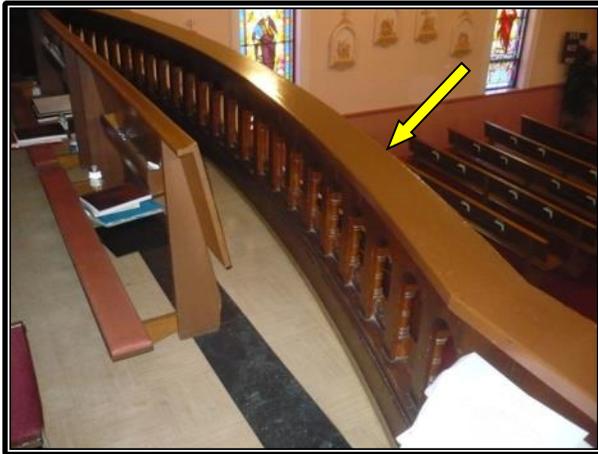
View of the railings which serve the mezzanine level of Site Building A.

Note: The railings were noted to be approximately 28" high and possess 6" openings between the spindles.

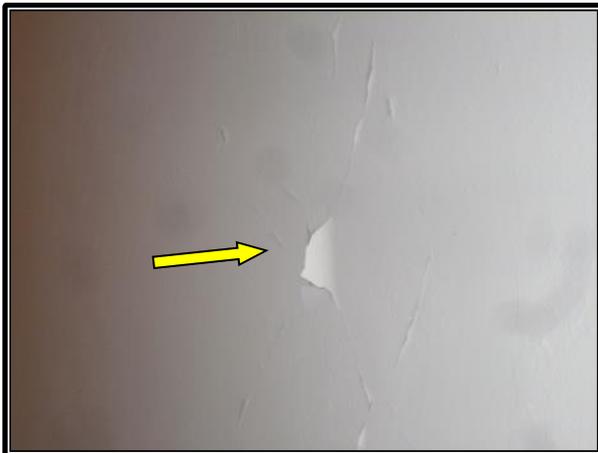
View of peeling paint on the plaster walls of Site Building A.

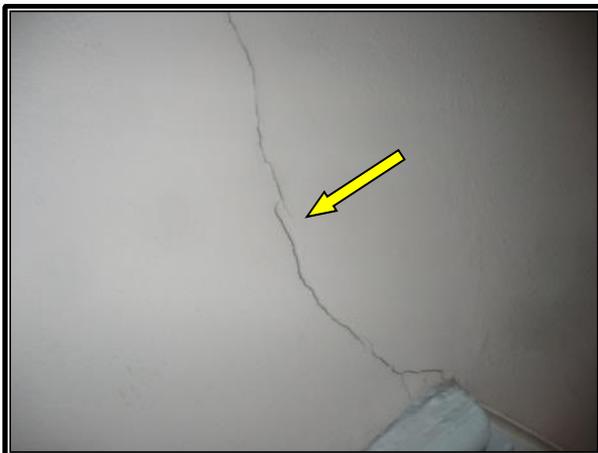
View of cracked plaster wall finishes in Site Building A.

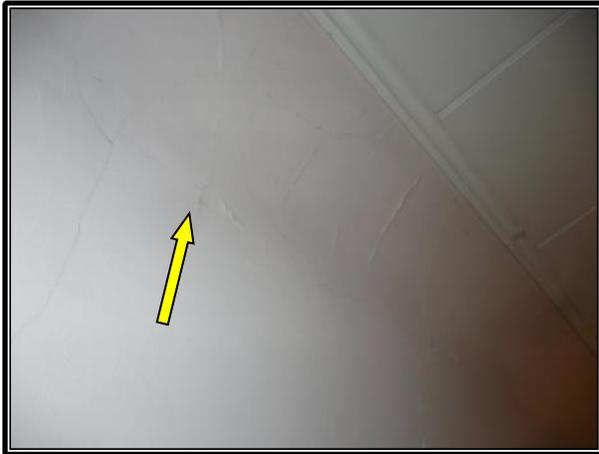
View of cracked plaster and paint finishes on the walls in Site Building A.

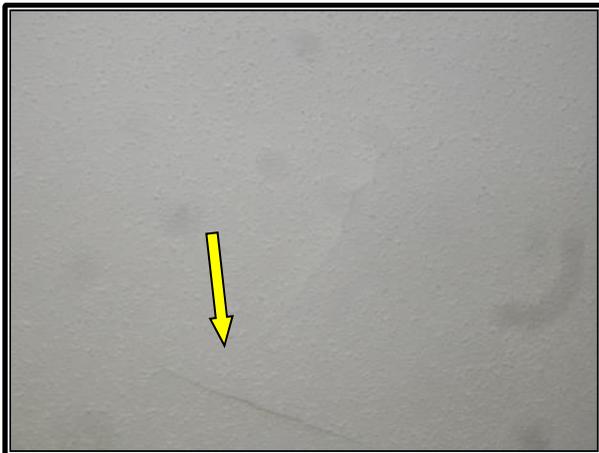
View of damaged stipple ceiling finishes located in the ceiling of Site Building B.

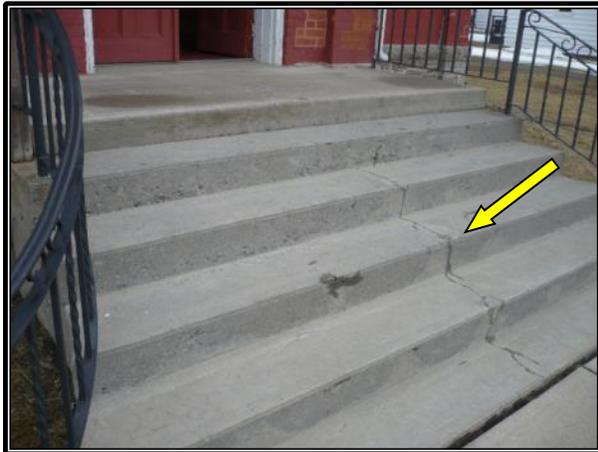
View of cracking in the cast-in-place concrete steps which provide access to the main entrance of Site Building A.

The Site features were noted to be in satisfactory condition with the exception of the isolated areas of cracking in the cast-in-place concrete walkways and steps. Pinchin has carried an allowance to seal the areas of cracking within the short term. Assessment of or comment upon concealed deficiencies and any buried/concealed utilities or components are outside the scope of work.

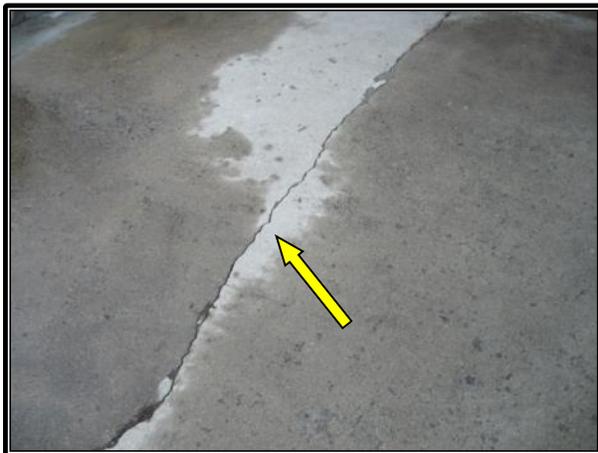
View of cracking in the cast-in-place concrete walkway located adjacent to the west elevation of Site Building B.

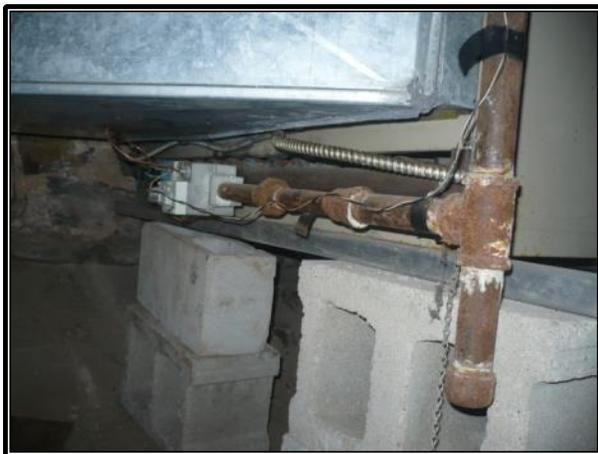
View of the burners which serve the natural gas-fired “Lennox” forced air furnace of Site Building A.

Note: The natural gas lines were noted to be corroded.
