**Baseline Property Condition Assessment  
Sacred Heart of Jesus Parish  
3060 John Street and 549 Middle Street  
Cardinal, Ontario**

Prepared for:  
Archdiocese of Kingston  
390 Palace Road  
Kingston, Ontario K7L 4T3

September 2013

Pinchin File: 78518.019

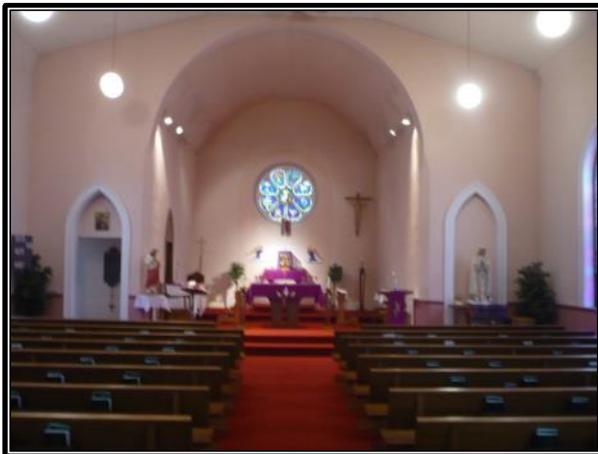
| <ul style="list-style-type: none"><li>• The railings serving the mezzanine level of Site Building A were noted to be 28" high and possess 6" openings between the spindles.</li><li>• Areas of cracked and peeling paint finishes were observed on the walls within Site Building A.</li><li>• Damaged stipple ceiling finishes were noted in the ceiling of Site Building B.</li></ul> | <ul style="list-style-type: none"><li>• Pinchin recommends that the balustrades (i.e., railings and spindles) be repaired/replaced due to the fact that they do not meet height and opening requirements.</li><li>• The areas of cracking in the plaster should be repaired and the areas peeling paint should be removed and re-painted within the term of the analysis.</li><li>• Repair the area of damaged stipple ceiling finishes.</li></ul> |

General view of the interior finishes within Site Building A.

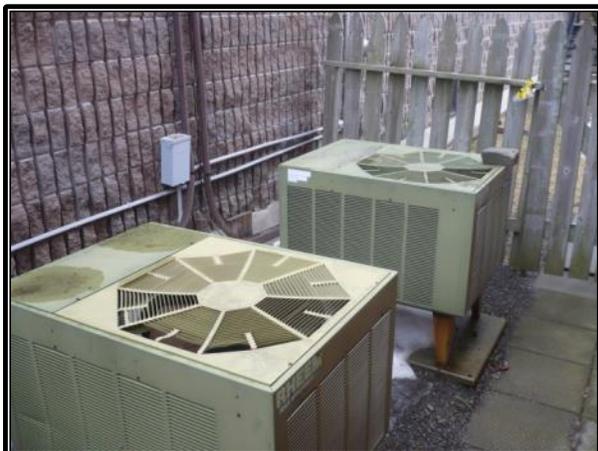
View of the “Rheem” condenser units which serve Site Building B.

- Replacement of the natural gas-fired forced air furnace serving Site Building A, along with refinishing of the rusted natural gas lines;
- Replacement of the two condenser units serving Site Building B;

In summary, the mechanical systems within the Site Buildings are currently in satisfactory condition, with the exception of the aforementioned minor deficiencies. Pinchin has included allowances for replacement of the forced air furnace serving Site Building A, the DHW heater serving Site Building B and the two condenser units serving Site Building B as they are expected to reach the end of their PUL within the term of the analysis. Pinchin also recommends that the rusted gas lines in Site Building A be re-finished or replaced within the term of the analysis. Pinchin recommends that a review of the fire suppression system be completed in Site Building B to determine if a fire suppression system needs to be installed above the kitchen stove. Assuming that the above noted deficiencies are addressed and regular annual maintenance is performed, no additional major expenditures are anticipated relating to the mechanical systems throughout the term of the analysis.

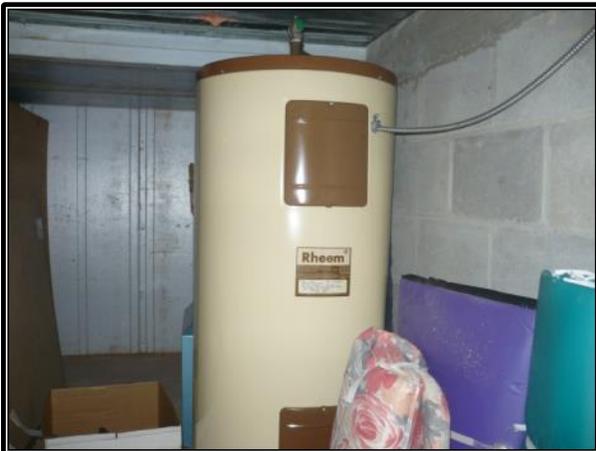
View of the "Rheem" DHW heater which serves Site Building B.

- Replacement of the DHW heater serving Site Building B;
- Replacement/repairs to the mezzanine balustrades which currently do not meet height and opening requirements; and
